MARINE EXPERT TELLS WHY TITANIC SANK

H. Brown, Well Known Writer on Engineering, Believes Forward Holds Filled.

ENGINE ROOM FLOODED TOO

Evidence Seems to Show That Two or More Adjoining Bulkheads Were Ripped Out.

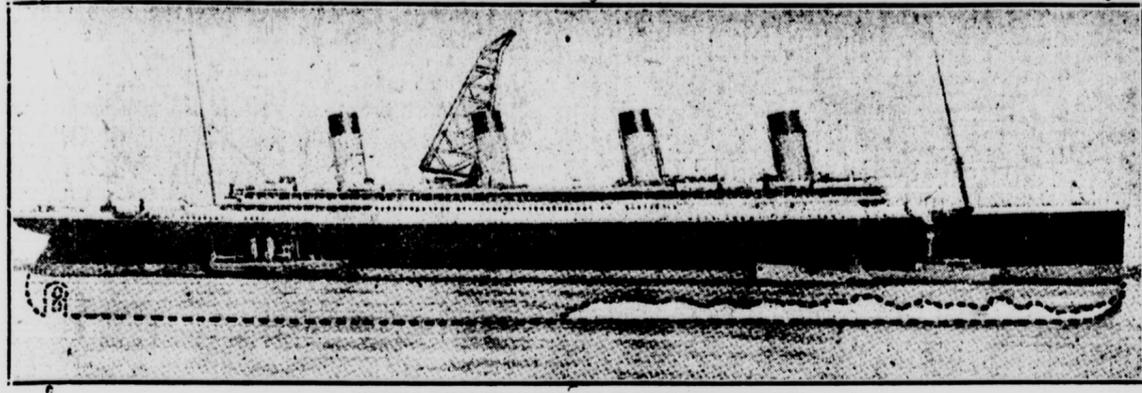
From the most authentic reports from the survivors of the disaster the ship was struck on the starboard side forward of the machinery space, probably between bulkheads two and three, by the submerged part of an iceberg, and as the vessel's course had been changed to avoid the collision the blow was probably a glancing one of sufficient force to crush or split the plates either above or below the water line. It is probable that the iceberg was pierced in several places for some distance aft, probably as far as the engine room. If the iceberg had been in the position of the large compartments from the forward cargo holds aft to the engine room began to fill with water.

From the fact that there was no heavy jar felt in the vessel from the collision, the crushing of the shell plates or opening of the riveted seams in about this position was probably not of great magnitude, as was done to the hull by the collision.

TITANIC, PROBABLE LOCATION OF RUPTURE OF SHELL.

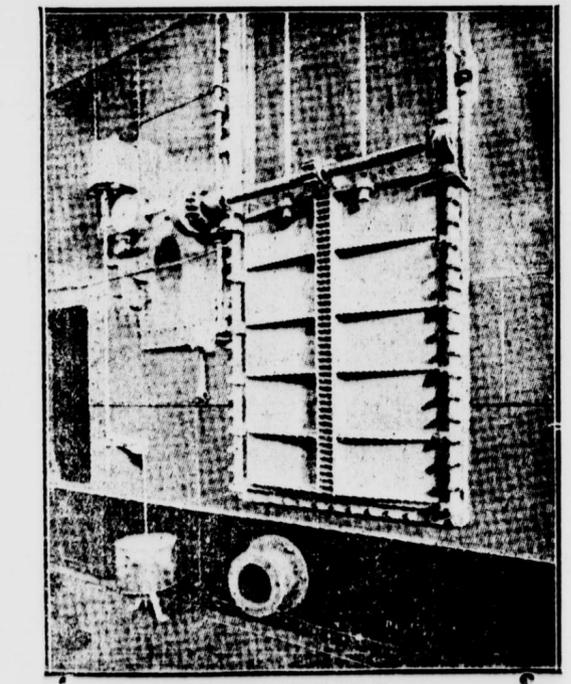
WATERTIGHT DOOR.

Whether the watertight doors which give communication between the various boiler rooms and engine rooms failed to close, as yet unknown. The doors were arranged on the drop system, each door being held in the open position by a friction clutch which could be instantly released by means of a powerful electro-magnet controlled from the captain's bridge so that the captain could by simply moving an electric switch instantly close the doors throughout the vessel. Other means were also provided for closing the doors, by operating levers when connected to the friction clutch and by floats which are provided beneath the floor level, so that if water entered the compartment it would automatically lift the float and close the door if it had not already been dropped by the mechanism connected with the bridge.
