# FINDS ELEMENTARY RULES OF ENGINEERING SLIGHTED

# DRAWINGS BY THEODORE L. CONDRON EXPLAINING KNICKERBOCKER COLLAPSE. SNOW FOUGHT WHILE FALLING UNDER PHILADELPHIA'S SYSTEM

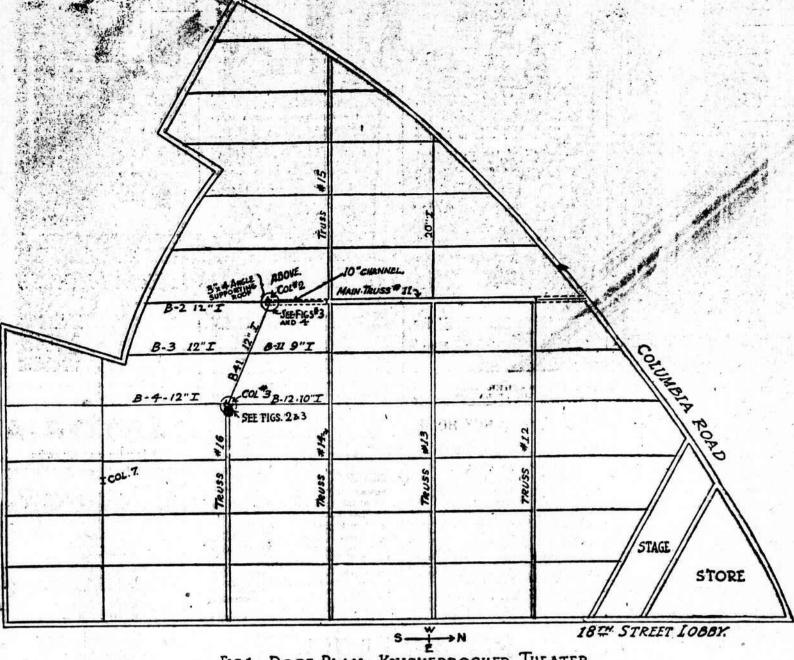
MG.1 ROOF PLAN- KNICKERBOCKER THEATER. Single Lines- Beas or Channel Double Lines- Trusses

sulted. In figure 1 the double lines indicate the six roof trusses, while the single lines indicate the steel I-beams or girders connecting with the trusses. Four of the trusses connected at one end of each to the main truss, No. 11. One truss, No. 16, extended from the east wall to column No. 5. The main truss, No. 11, was at right angles to the other trusses, and its north end rested upon the curved wall on the Columbia road side of the building. Its south end was supported on the upper end of a column (No. 2), at the level of the ceiling. This column, unlike column No. 3, did not extend to the roof, but stopped at the level of the suspended ceiling, which was about six or seven feet below the

It is difficult to determine what the loads and stresses were in the balcony framing. An addition was made to the balcony last summer, the details of which the writer has not seen. A glance at figure 1 will show that any disturbance of the equilibrium of the framing at either of the supports over the two columns. Nos. 2 or 3, would be fatal.

Referring back to figure 1 it will be noted that in case any force tended to disturb the equilibrium of the point of support over column No. 2. and cause a movement of B-41 would tend to upset the light angle strut, which rested so insecurely on top of the rested to the relative positions and the unbraced condition above the balcony of column No. 2 and also of the angle strut above it. When first creeded there was no member in the plane of the ceiling between columns No. 2 and also of the angle strut above it. When first creeded there was no member in the plane of the ceiling between columns No. 2 and also of the angle strut above it. When first creeded there was no trigidly connected by two bolts to the flange of the truss through a flat plate.

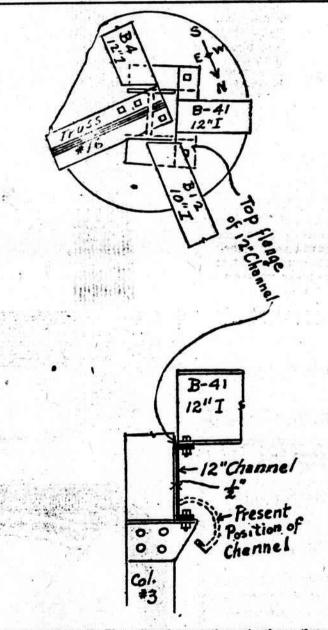
Upper: Figure 2—Plan of roof connections at column three.
Lower: Figure 3—Side view of connection of beam B41—to channel at
mn three—only the bottom flange of channel connected to the column.

Figure 2 is a sketch to larger scale, of the top of column No. 3 and shows the relative positions of the four roof members connecting at this column. Perhaps it is well here to call attention to the fact that all of these connections were made with loose fitting bolts instead of rivets It may be permissible to make steel connections with bolts in a framework of short spans, but good practice dictates the use of field driven rivets in the connections for work of this character. Where bolts are used the number should always be greater than would suffice for rivets, which is not the case here.

Figure 3 is an elevation or side view of a part of the connection shown in plan in figure 2. This shows that the twelve-inch I beam "B-41" was connected in a most flimsy fashion to its support, which was a short section channel twelve inches high and half an inch thick, standing on angle brackets, connected to the column.

The upper flange of this channel was not fastened to the column in any way, so that a very slight movement of beam "B-41" would certainly cause the web of the channel to fold over, bending near its bottom flange, and this is just what did shappen to this channel support, as shown by dotted lines on figure 3.
