OFFICIAL FINDINGS ON F-4 DISASTER MADE PUBLIC

NAVY BOARD ABSOLVES OFFICERS AND MEN OF ALL PERSONAL BLAME

The report in full is as follows: "Navy Department, "October 25, 1915. "The Navy Department has received the report of the Board of officers appointed to investigate the cause of the loss of Submarine Boat F-4. The conclusions of the Board are as follows: "1. The accident which caused the loss of the U. S. S. F-4 on the morning of March 25, 1915, occurred before the vessel reached the predetermined depth for which the automatic blow had been set—which depth, the board assumes, was less than 150 feet, as required by the Department's Order."

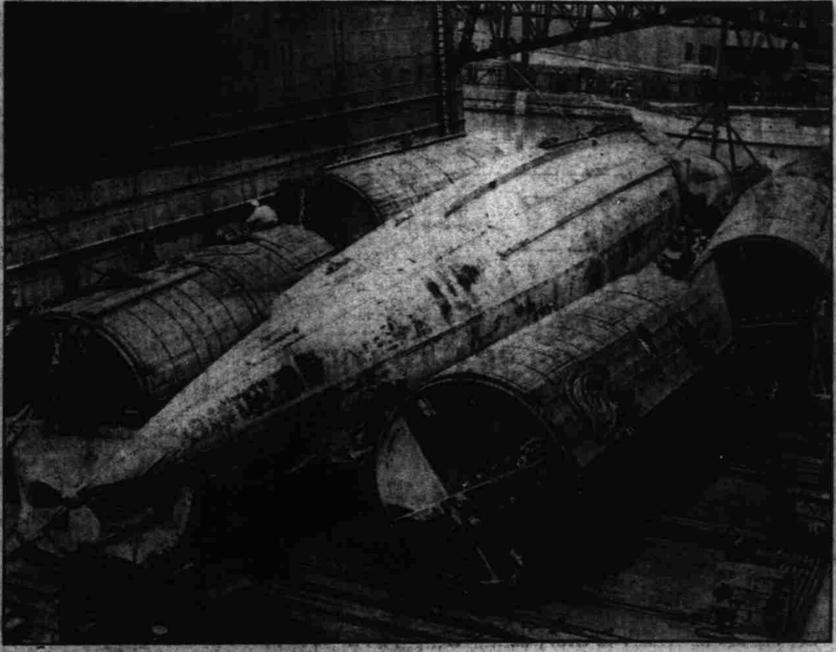
The gist of the findings is as follows: "The primary cause of the disaster was the corroded condition of the lead lining of the battery tank, and, in consequence, of certain rivets in the port wall of the forward battery steel tank."

Submarine F-4 In Drydock After Disaster
