MONTANA

Farmer-Stockman

70,000 Acres Salvaged

Drainage Ditches Open New Frontier

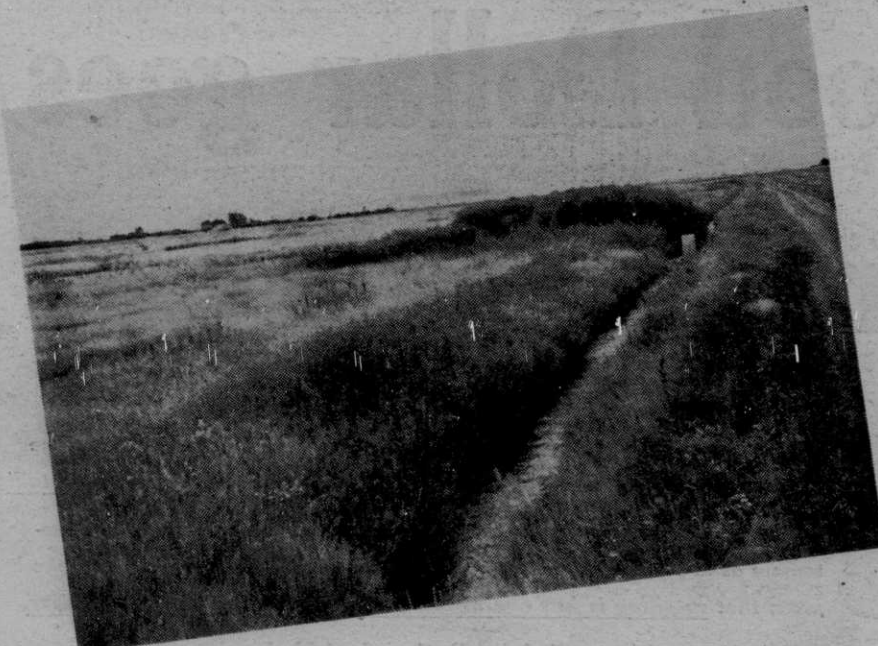
Over-all view of some of the wet land in Montana that needs drainage. This picture was taken near Lowry, Mont. Weeds, willows and undesirable grasses are the principal vegetation.

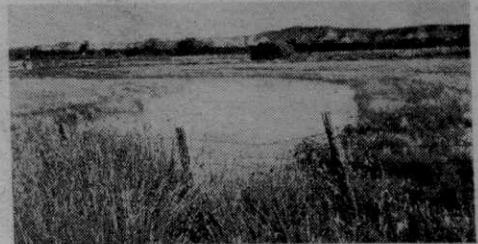
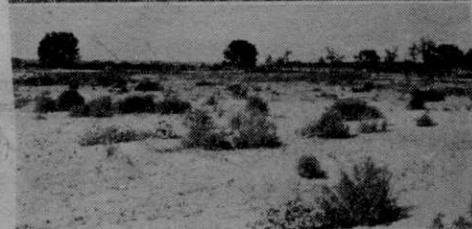
—Photo by Soil Conservation Service
Cause and result. The slough in the upper picture rises and lowers with the water table. At the time this photo was taken in June, 1949, the water table was near the surface; test wells in the area confirmed what the slough showed. The lower picture shows a few remaining alfalfa plants on what is described as having been a good field of alfalfa. The high water table has caused nearly all of the plants to die. This picture was taken on Pease Bottom near Hysham, Mont., in the Treasure county soil conservation district.

Having to drain land in order to be able to irrigate it may seem a paradox to many people. But the fact remains that even in this low-rainfall country, where irrigation is practiced, the ground water level is so high in many places that only sedges and other low quality vegetation can grow. Besides this, a high water table often brings salts to the surface.

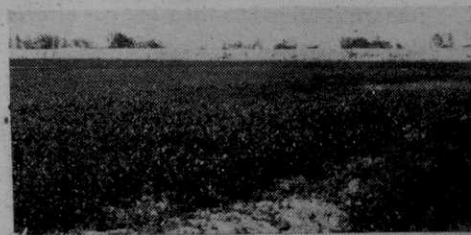
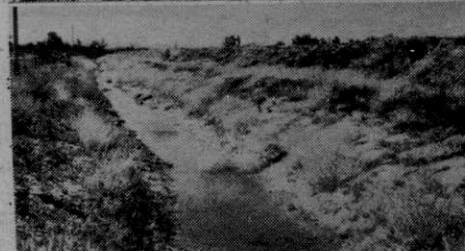
Two views taken June 30, 1949, at the Harvey Naslund place near Chinook. The wheat in the top picture is on a field where the drainage system was built in 1948. Previously during the 10 years he had lived on the farm, Naslund said, this land was so seeped that it produced only a little grass—"it wasn't even fair pasture." The banks of the main drain can be seen in the background. The lower picture shows the main drain, which is separated from Naslund's land only by the width of the road. Naslund is co-operating with the Paradise soil conservation district.

Harvey Naslund near Chinook, co-operating with the Paradise soil conservation district, has a 35-acre irrigated field that in 1949 produced a good wheat crop, on land first drained in 1948. For the 10 previous years that he had been on the farm, he said, this field had produced only a little grass. It wasn't even fair pasture.
